AIRCRAFT ACCIDENT & INCIDENT
INVESTIGATION BOARD CYPRUS

**FINAL REPORT ON THE ACCIDENT OF PARAMOTOR GLIDER (SERIAL No. 000990) WHICH
CRASHED IN AKAMAS PENINSULA ON 05 AUGUST 2014**

Aircraft Type and Model: Paramotor, Parajet (Zenith) airframe fitted with a Polini Thor 100 engine.

Location: Approximate position 35 04 48N – 032 18 36 E in Akamas Peninsula, close to Spitia tis Rigenas

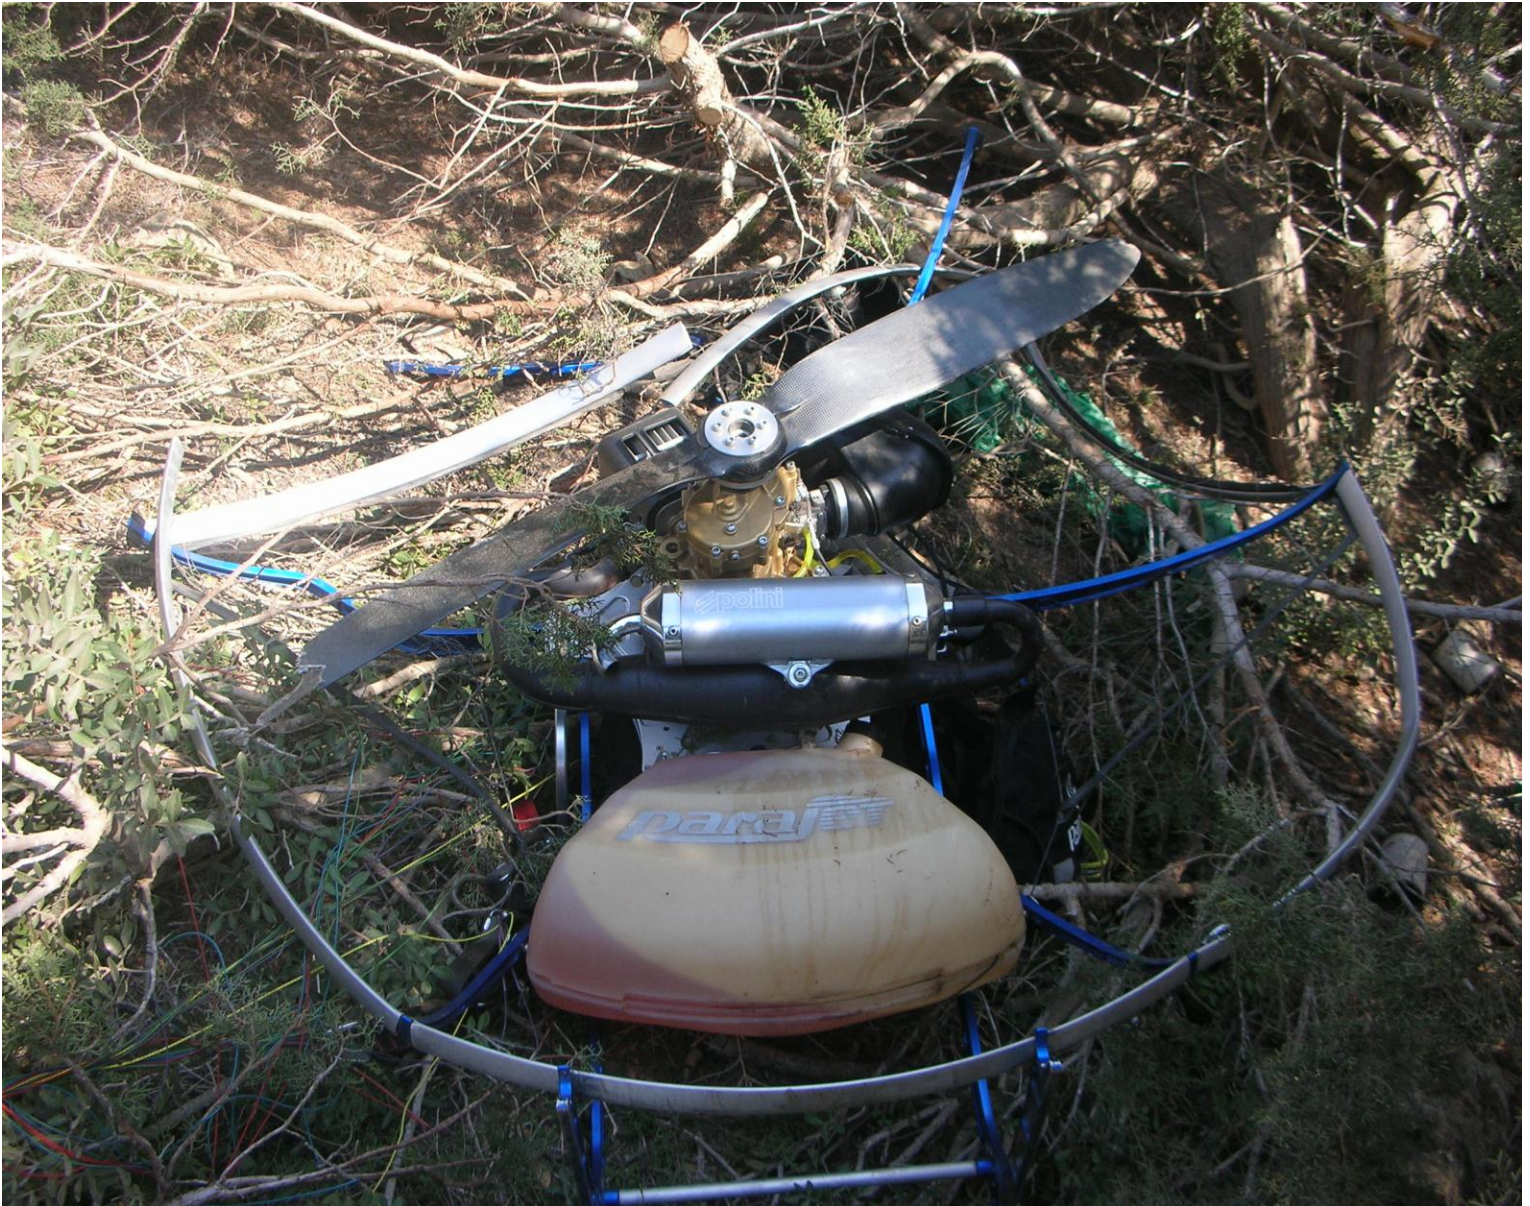
APPENDIX 1

Both tips of the propeller were damaged due to the impact. The three top blue spars that form the outer section cage and the three of the outer ring section found bent due to the impact with the ground.
