FINAL REPORT

ACCIDENT INVOLVING A DA42 AIRCRAFT

47NM SOUTH EAST OF LARNACA

ON THE 22ND OCTOBER 2014

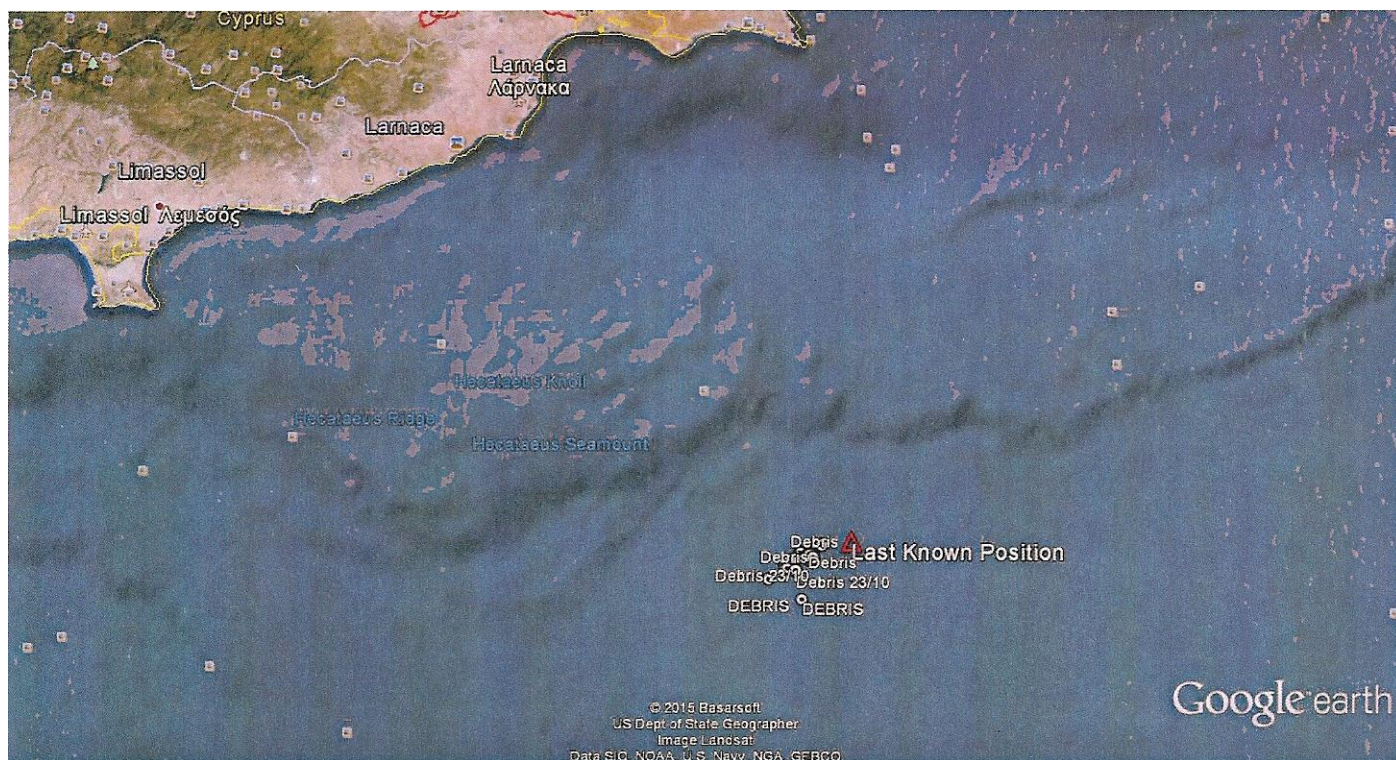
APPENDIX 1

Pieces of wreckage were scattered in a relatively small radius from the impact point. Satellite images inserted. See Appendices 1 and 2.

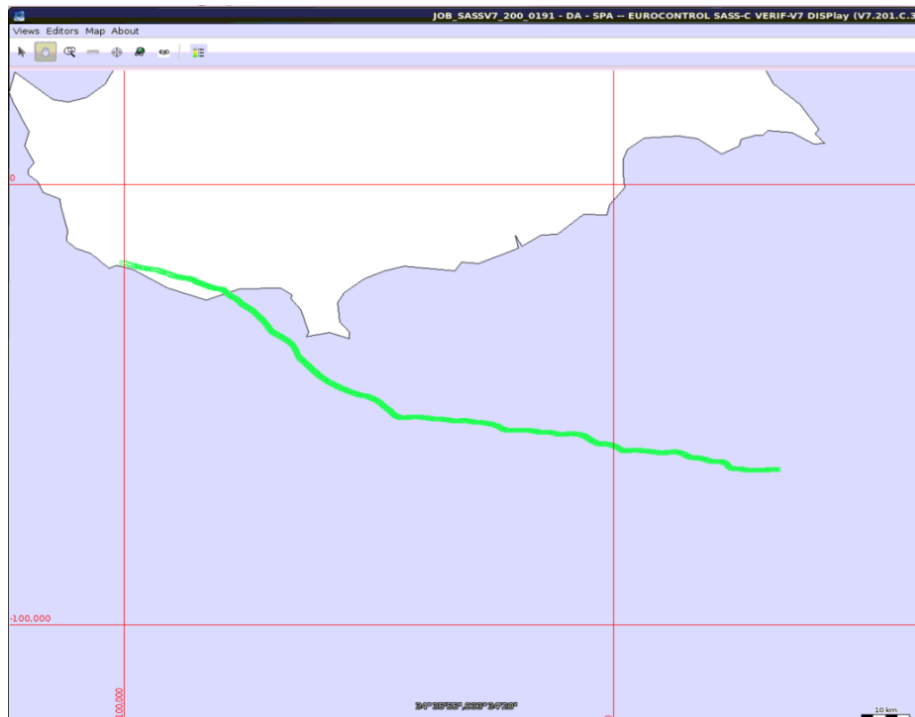
APPENDIX 3

Chronological Narrative and observations based solely on the radar data and without taking into consideration any conversations the PIC may have had with ATC.

The above image displays the reconstructed track of 5BCLI departing from Paphos up to 16:00 UTC at which point the recording continues, as illustrated by the analysis on the next pages.

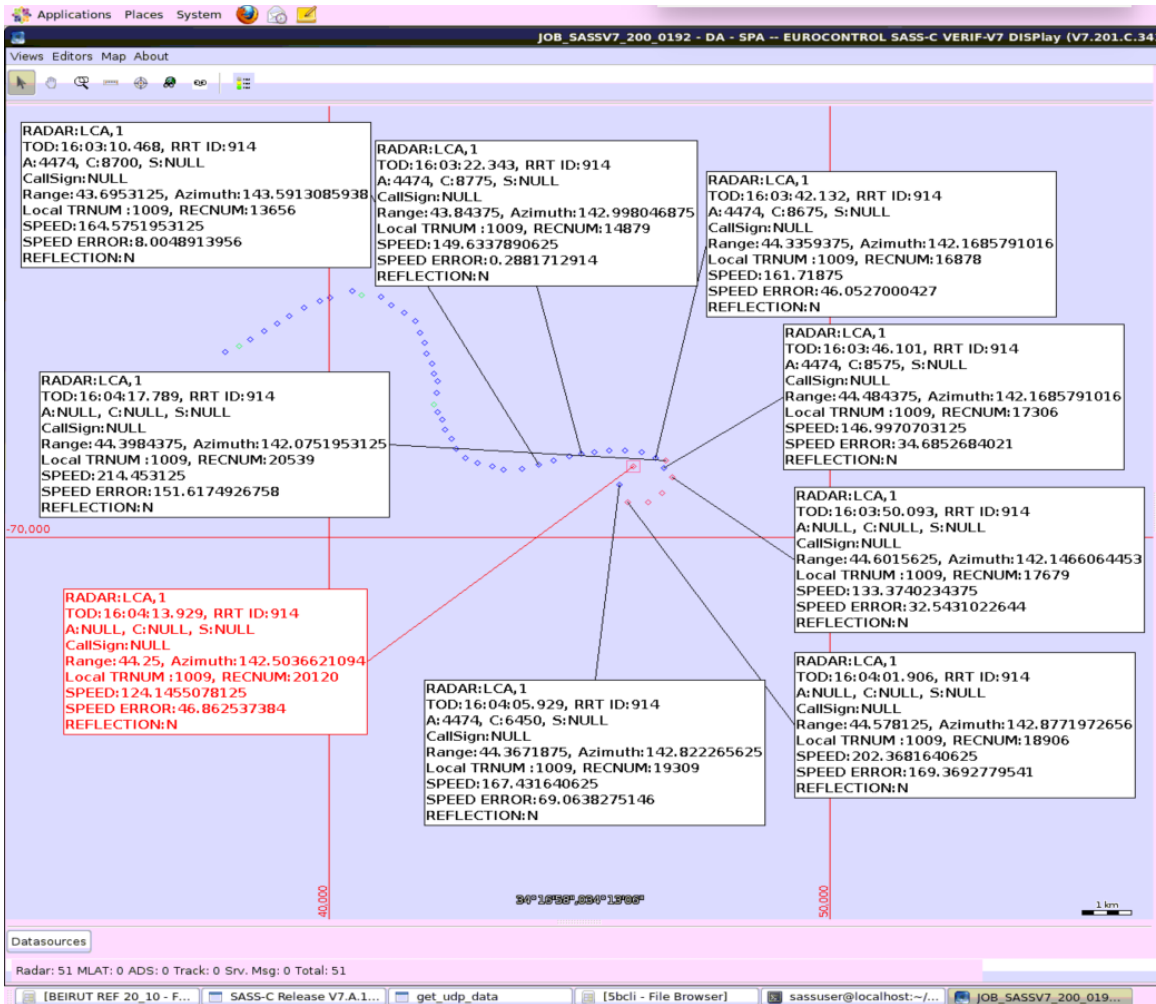
APPENDIX 4

Above image displays the reconstructed track of 5BCLI based on Larnaca Radar readings.

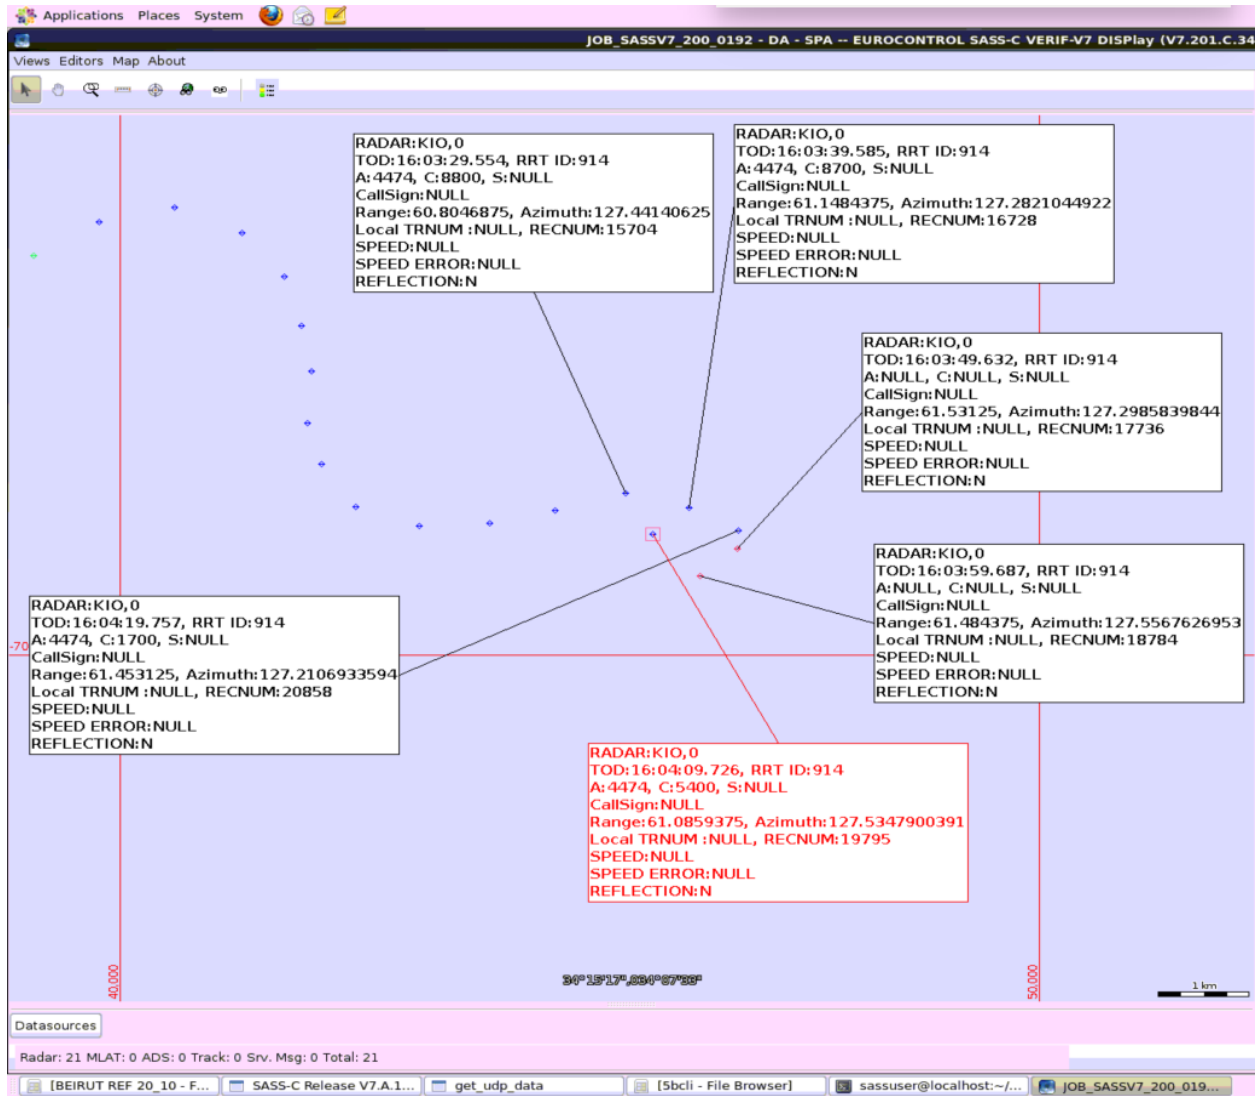
APPENDIX 5

Above image displays the reconstructed track of 5BCLI based on Kionia (In Cyprus) Radar readings.

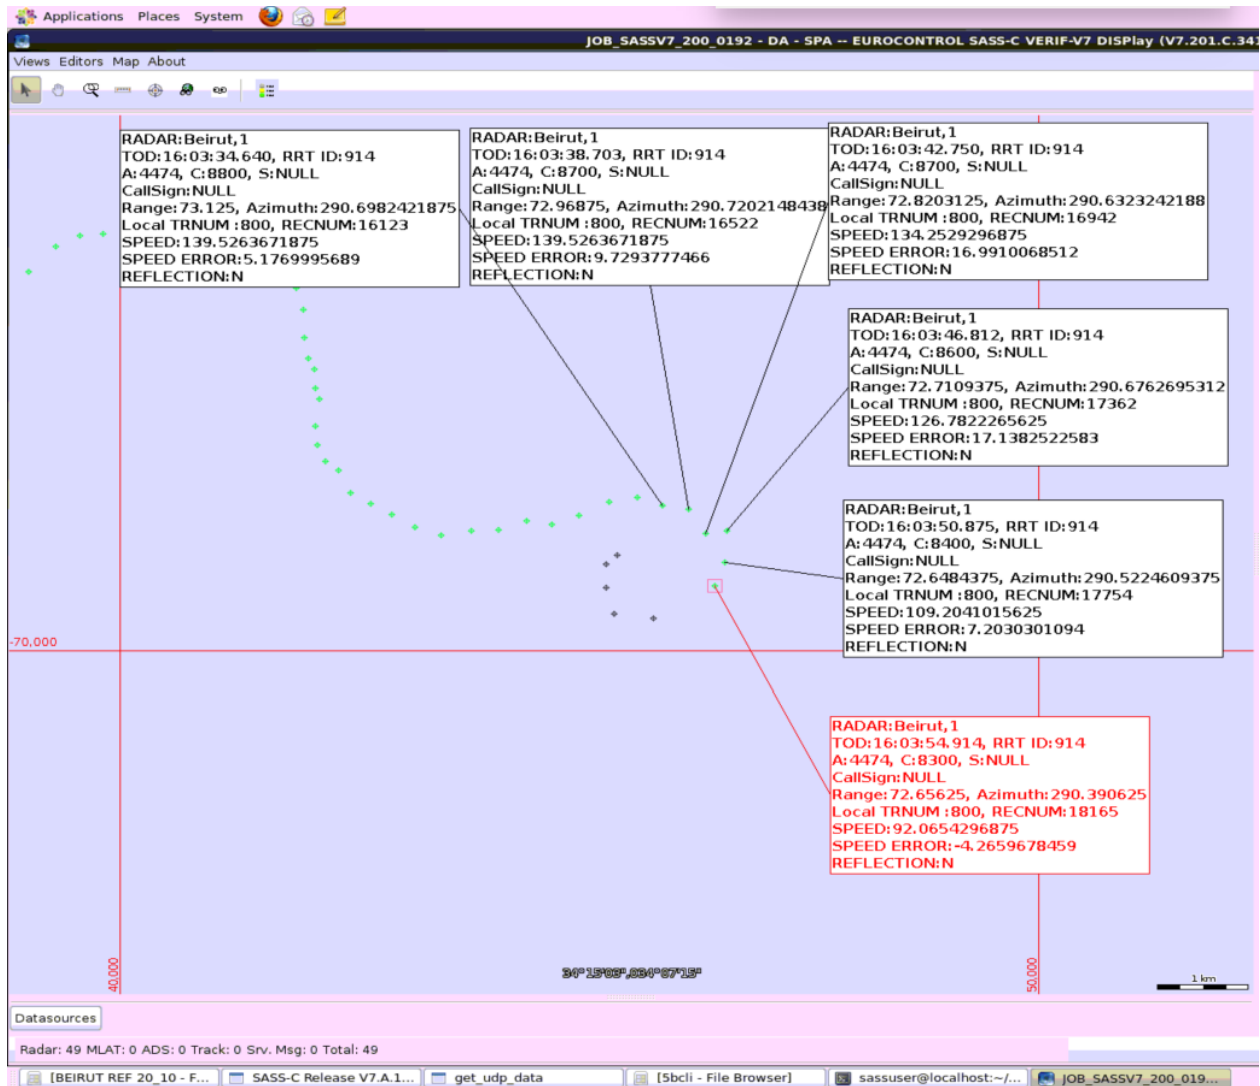
APPENDIX 6

Above image displays the reconstructed track of 5BCLI based on Beirut Radar readings.
